A DATA PROCESSING POTPOURRI OF POWER QUALITY PROBLEMS

Patrick J. Lynch, P.Eng.

Power Line Systems Engineering Inc.

1999 Conference - Chicago

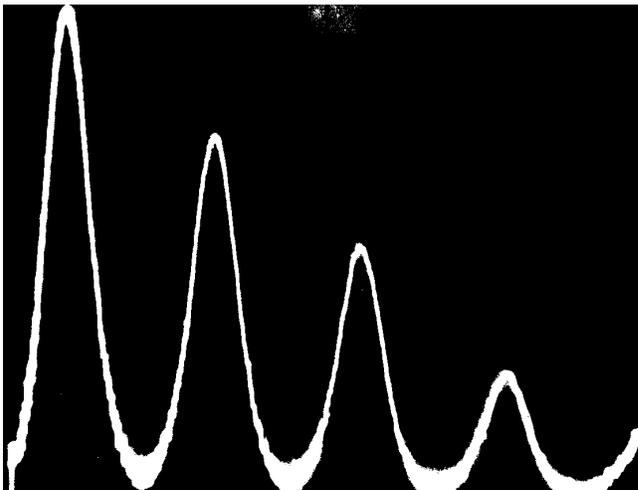
PICTURE #1
CHEQUE ENCODING MACHINE
"FED WITH STANDARD UTILITY POWER" AT SITE 1
PHASE CURRENT - HARMONIC FREQUENCY SPECTRA

TRUE R.M.S. CURRENT: 1.7 AMPS

- 3rd Harmonic - 75% compared to the fundamental
- 5th Harmonic - 50% compared to the fundamental
- 7th Harmonic - 25% compared to the fundamental

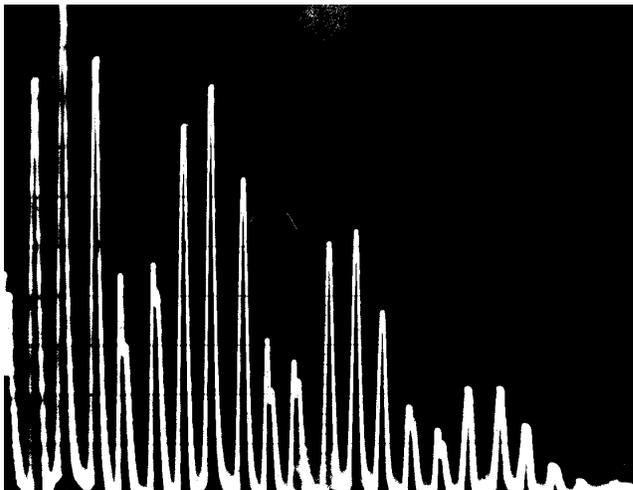
PICTURE #2
CHEQUE ENCODING MACHINE
"FED WITH RAW UTILITY POWER" (ON COMMON U.P.S. FEED) - SITE 2
PHASE CURRENT - HARMONIC FREQUENCY SPECTRA

NOTE: Harmonics approximately every 30 Hz. Several frequency components 50% to 100% Larger than the fundamental. Machine automatically shuts down every 5 to 10 mins.

NOTE: With the same machine, the current doubles at Site 2

1. Electrically feed the cheque encoding machines directly with U.P.S. power.
2. Supply all the cheque encoding machines with ferroresonant transformers.
3. Re-design the U.P.S. filtering to further attenuate the harmonics generated at the input side of each U.P.S.
4. Electrically feed all the cheque encoding machines with clean utility power (not contaminated with U.P.S. harmonics).

A large ferroresonant transformer was temporarily loaned to the customer to "power up" all the cheque encoding machines at this site. This enabled the customer to clear the cheque backlog and resume normal daily operations and avoid any further financial penalties. It also provided some "breathing room" to examine each of the above options more closely.

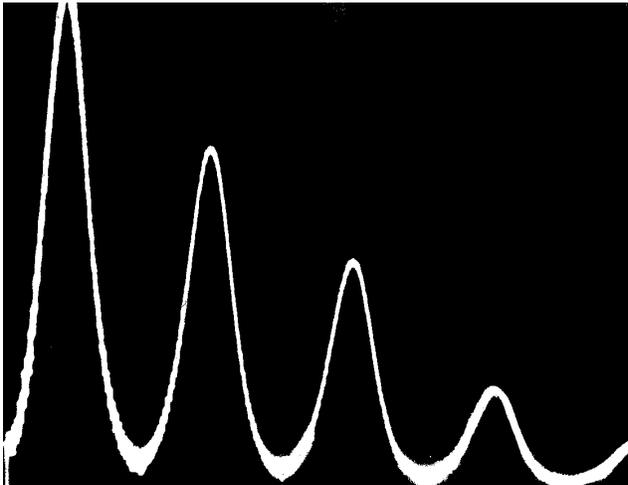
FACT 3: We then brought in a small portable 1:1 ferroresonant transformer and plugged it into the wall outlets at the failed site. The cheque encoding machine in turn was "plugged into" this ferroresonant transformer. The current draw to this machine immediately dropped to approximately the same value as at the original site (nameplate value). The machine that was plugged into the ferroresonant transformer no longer failed, but all the other machines on each side of it still continued to automatically turn off after 5 to 10 minutes of operation. A typical ferroresonant transformer works on a saturated transformer core principle. Because the core is saturated, it severely attenuates the flow of harmonics between input and output.

PICTURE #3
CHEQUE ENCODING MACHINE
"FED UTILITY POWER TO FERRO TYPE TRANSFORMER" - SITE 2
PHASE CURRENT - HARMONIC FREQUENCY SPECTRA

- 3rd Harmonic - 70% compared to the fundamental
- 5th Harmonic - 45% compared to the fundamental
- 7th Harmonic - 20% compared to the fundamental

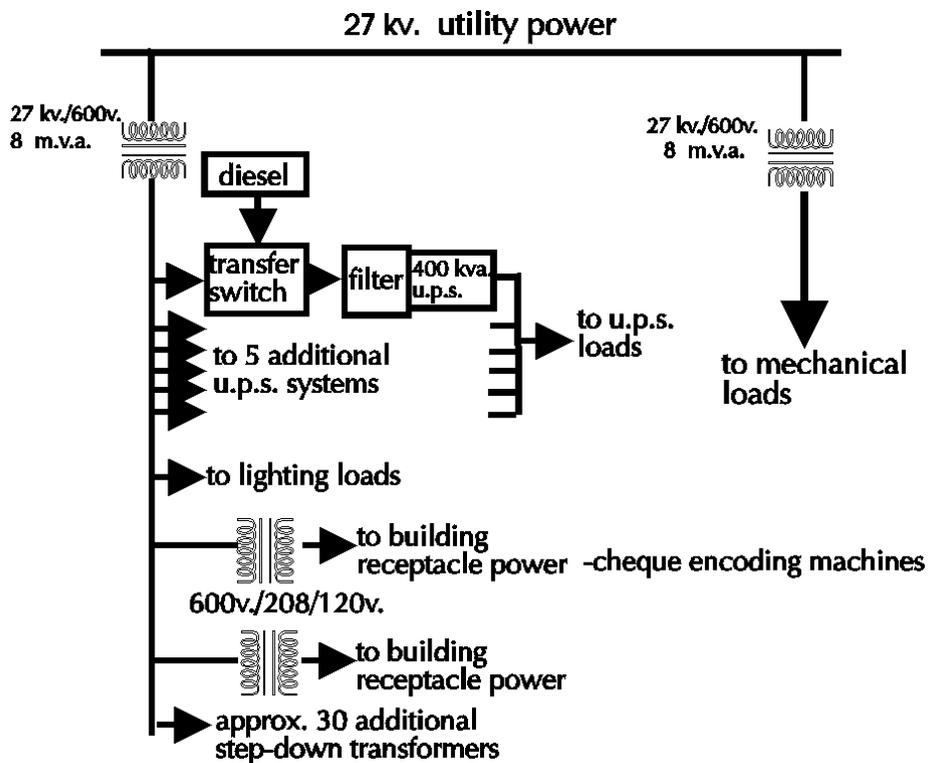
DIAGRAM 1
DATA PROCESSING CENTRE
SIMPLIFIED SINGLE LINE ELECTRICAL SCHEMATIC

The above single line (Diagram 1) shows six (6) paralleled 400 KVA. U.P.S. modules are fed from the same utility source as are the lighting and auxilliary receptacle power for this building. A separate main incoming step-down transformer is used to feed all the mechanical equipment. Each U.P.S. module is equipped with an input harmonic filter for the 5th, 7th, 11th and 13th harmonics. Even with the U.P.S. harmonic filters in place, we still suspected harmonic interaction was occurring between these U.P.S. systems and the cheque encoding machines. To confirm our suspicions, the U.P.S. was transferred from utility power to diesel power. With the U.P.S. isolated from the utility supply, the phase current draw immediately dropped from 3.4 Amps to 1.7 Amps for all of the cheque encoding machines. At the instant utility power was restored to the input of the U.P.S., the current to each of the cheque encoding machines doubled again.

These test results confirm the U.P.S. system was the source of the problem. All the U.P.S. input harmonic filters were then checked against specification, both by ourselves and the U.P.S. manufacturer. The test results confirmed all the filter units were all within design specification limits.

With the cost being nominal, it was decided on a "trial basis" to change the main 600 Volt transformer / receptacle feed from the feed common with the 600 Volt U.P.S. feed to the 600 Volt feed common with all the mechanical loads (chillers, pumps, fans, etc.). The mechanical power feed has traditionally been termed the "dirty feed". However, in comparison to the utility U.P.S. feed at this site, it was relatively clean (Refer to above Pictures #4 and #5). All receptacle power in this building has now been converted over to this mechanical electrical feed as the final solution. The cheque encoding machines have been connected to this feed for approximately 5 years now without experiencing any further problems.

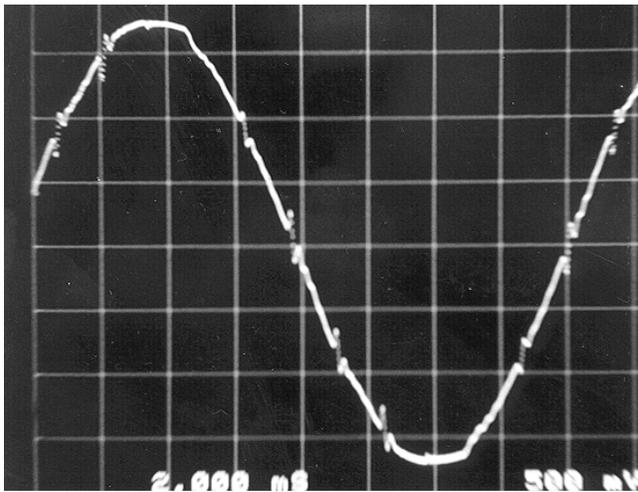
PICTURE #4
CHEQUE ENCODING MACHINE
(COMMON UTILITY POWER TO U.P.S. INPUT FEED)
VOLTAGE WAVEFORM

TRUE R.M.S. VOLTAGE:
120 VOLTS - T.H.D. 4.1%

NOTE: DISPLAYS MINOR SYMMETRICAL NOTCHING

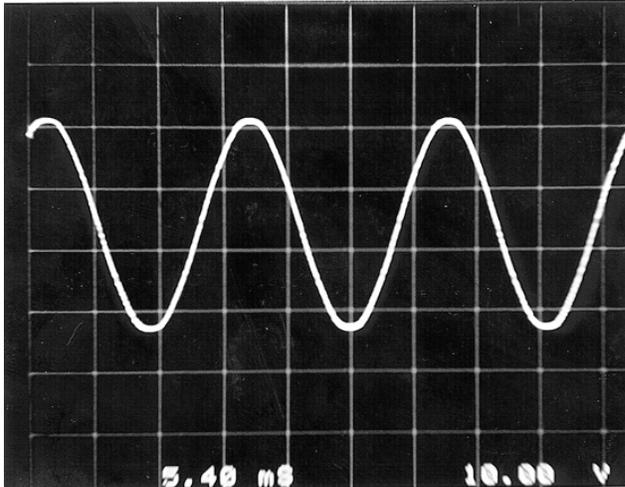
PICTURE #5
CHEQUE ENCODING MACHINE
"FED WITH (MECHANICAL FEED) RAW UTILITY POWER"
120 VOLT VOLTAGE WAVEFORM

NOTE: ABSENCE OF U.P.S. SCR SYMMETRICAL FIRING TRANSIENT

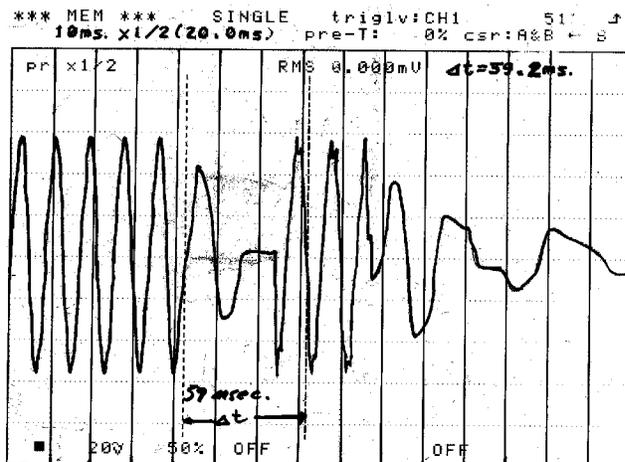
PICTURE #6
U.P.S. INPUT VOLTAGE WAVEFORM DURING TRANSFER
LOAD SIDE OF BREAKER
U.P.S. INPUT FILTER CONNECTED

NOTE: Breaker tripped within 3 power cycles after transfer

A high speed voltage chart recorder was next installed on the load side of this breaker. It was observed that the voltage present on the U.P.S. input breaker during this 35 to 50 millisecond transfer "dead time" appeared to be a slowly decaying voltage waveform (Refer to Picture 6). NOTE: The input breaker tripped after transfer by approximately 3 power cycles.

1. Disconnect this input filter, to prevent the U.P.S. intermittent input breaker trips.
(NOTE: Refer to Table 1 for the resulting increases in phase current T.H.D. levels within this facility.)
2. Install a timer circuit or transfer switch control signal to momentarily disable the filter circuit during re-energization.
3. Eliminate "hot" diesel transfer switch testing on these U.P.S. systems.

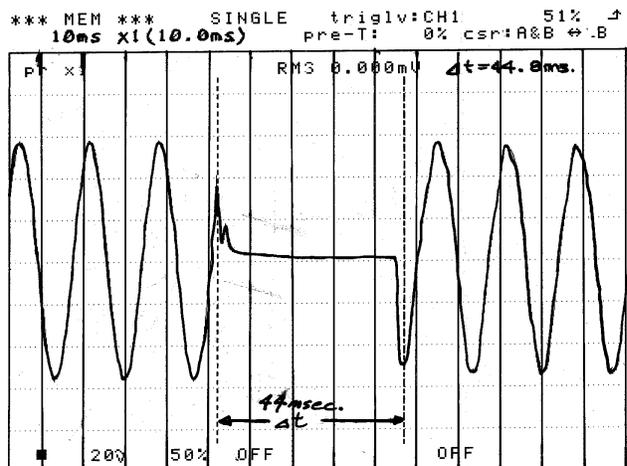
PICTURE #7
U.P.S. INPUT VOLTAGE WAVEFORM DURING TRANSFER
LOAD SIDE OF BREAKER
U.P.S. INPUT FILTER DISCONNECTED

With the U.P.S. input filter capacitive components disconnected, during the transfer "dead time" (Refer to Picture #7), the decay voltage appearing on this input breaker was now practically zero volts. A small voltage sag also occurred when transferring to the diesel system. These results tend to support a hypothesis that the residual filter capacitive charge is inherently biasing the iron core material within the U.P.S. Upon re-energization, large harmonic inrush currents from the diesel power are travelling through this biased core material and causing the U.P.S. input breaker to quickly trip. The inductance in the length of cable to this particular U.P.S. module and filter components have uniquely combined to intermittently draw (dependant on the transfer point on the voltage waveforms) excessive inrush current and trip this input breaker.

To test this hypothesis, it was decided to remove all input filtering from the six (6) U.P.S. systems and test various combinations of loading conditions and transfer voltage source scenarios during transfer. Over 100 transfers were performed on all these U.P.S. module systems. The results are quite simple. There was no longer any magnetic core snapping sounds during transfers and not one U.P.S. input breaker tripped.

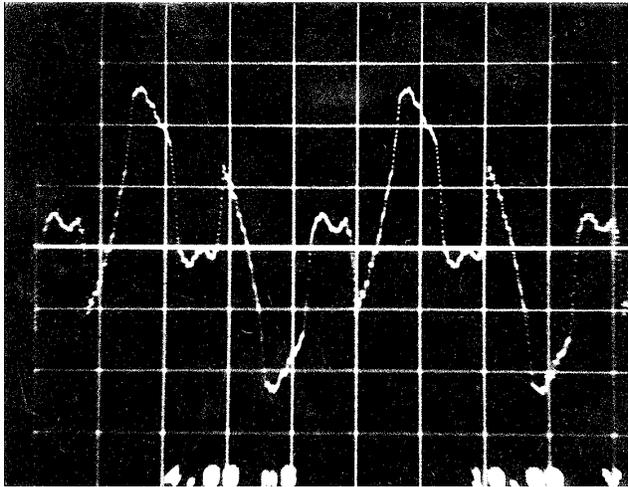
PICTURE #8

Vertical Scale:
MAGNETIC FIELD -
35 MILLIGAUSS TRUE R.M.S.

We were then asked by our client to come in and investigate the phenomenon more fully. Low frequency magnetic field readings indicated there was a 30 to 40 milligauss A.C. field present. Harmonic frequency spectra pictures revealed 3rd harmonic components present almost equal to the fundamental (Refer to Picture #8 and #9).

The periodic increases in all the computer screen text wavering related to an approximate 10 to 15 times increase in magnetic field, primarily the 60 Hz. component peaking at 590 milligauss. The magnetic field became stronger towards the ceiling area. Upon removing the ceiling tiles, it was discovered a main 13 KV. high voltage cable system was visible and went directly through this area to the nearby electrical room.

1. Magnetically shield the ceiling area.
2. Magnetically shield the computer monitors.
3. Change monitor screens to a less sensitive monitor type.
4. Relocate this data processing activity and re-assign this area as non-computer use only.
5. Relocate the offending power cable runs.

Entering into the client's decision making process, was also the underlying concern with respect to potential employee health concerns. The employees would be exposed to these magnetic fields continually throughout an 8 hour working day. Medical scientific research and government regulation standards at the present time are not clearcut or straightforward. With respect to any potential future employee class action lawsuits, our client chose a cost-effective prudent avoidance approach. In this particular situation, the low voltage power cable run was re-located outside the building away from any employee areas.

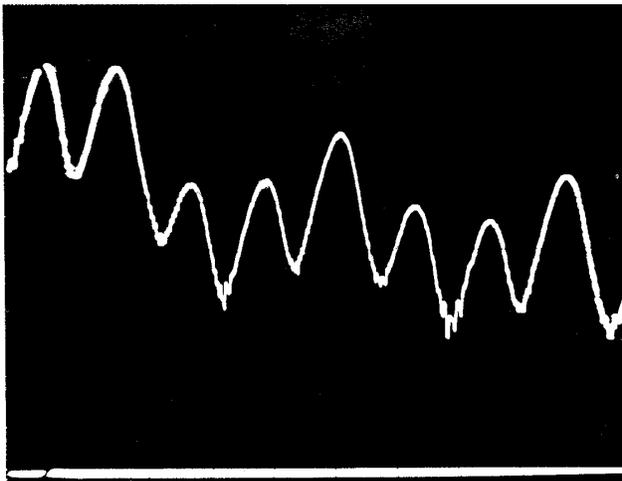
PICTURE #9

3RD Harmonic - almost equal to the fundamental

revealed relatively high levels of 3rd harmonic magnetic field components. This is not a typical magnetic field harmonic spectra generated by a high voltage cable! Generally, on a high voltage system, it has been our experience these frequency components are severely attenuated through the downstream step-down transformers. Upon reviewing as built drawings, it was discovered, a high current electrical feeder was in conduits within the poured ceiling concrete floor slab. These conduit runs were in the same vicinity as the computer screens with the constant screen text wavering. In addition to computer loads, part of the downstream electrical load on this feeder was the chiller system. Every 20 to 30 minutes, these chillers would cycle on and cause an increase in start-up inrush current, which corresponded to the higher magnetic fields measured in this computer room area. Various neutralizing options were then examined by the client at this point:
