## **SPINNING OUT OF CONTROL**

By Patrick J. Lynch, P.Eng.

Presented to Electricity Today Forum - 1998

### **CASE STUDY #1**

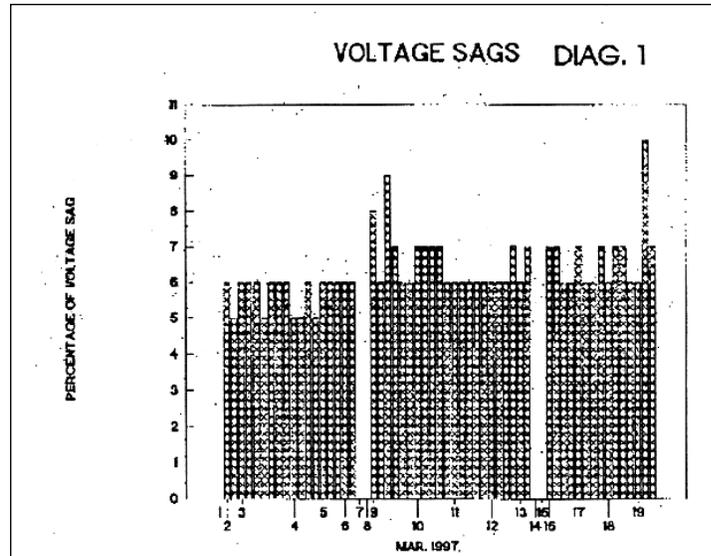
The first step was to perform a detailed electrical system analysis at this plant to determine if any electrical system abnormalities existed. The measured incoming 600 Volt voltage waveforms were sinusoidal and within acceptable voltage T.H.D. values. The phase load currents ranged from 150 to 200 Amps with all harmonics less than 30 dB. compared to the fundamental (ie. Within acceptable current T.H.D. levels). The plant's overall power factor was .8 to .83 lagging. Measured voltage sags were up to 10%, lasting up to 1/2 second in duration (Refer to Diagram 1).

These voltage sags were found to be generated by the owner's other equipment during start-up and did not cause the metal spinning equipment to crash. High speed voltage transients captured at this site, on the 600 Volt service, were up to 1000 Volts lasting 2 to 3 milliseconds in duration (Refer to Diagram 2).

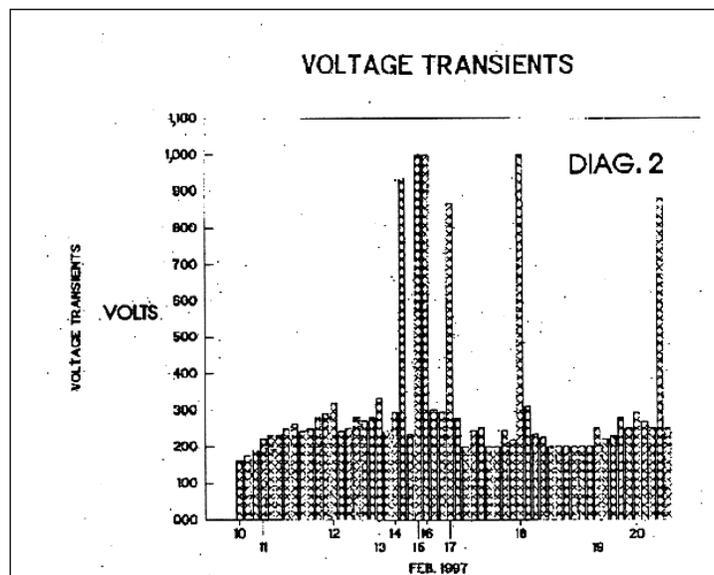
The occurrence of these voltage transients correlated exactly with the metal spinning equipment failures. The voltage waveform high frequency ringing oscillation was a typical "DNA" characteristic trace for utility capacitor grid switching (Refer to Diagram 3).

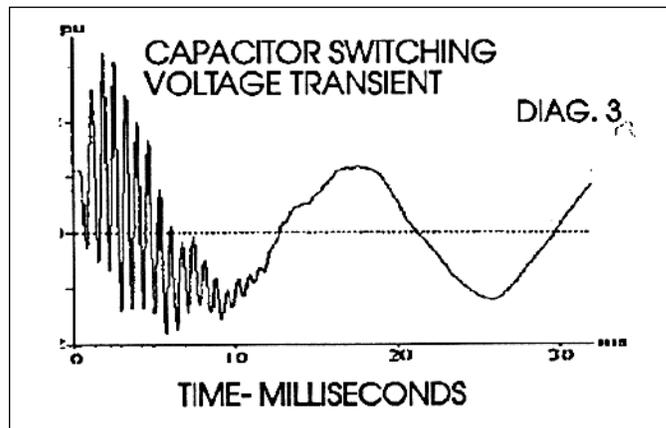
The utility was then contacted and confirmed capacitor switching had occurred at their substation at the exact same times of these voltage transients and subsequent metal spinning equipment failures. The source of the problem apparently had been found, but the arguments still remaining were:

The plant's power factor correction capacitor, located on this subfeeder as mentioned, was overcorrecting the power factor and actually amplifying the effect of this utility capacitor grid switching effect. The actual mathematical electrical analysis of this transient behaviour is beyond the scope of this present discussion.

They are achieving the desired end result (ie. Increasing the power factor from .7 to .8 and reducing subsequent utility demand charges) but they are also overcorrecting the power factor on this subfeeder within the plant. With the plant's capacitor bank turned on, this subfeeder's power factor was **overcorrected to .3 leading**. This subfeeder just happens to be on the same electrical feeder supplying the metal spinning equipment. Is this a coincidence? It was then calculated the extra utility demand charges with this capacitor bank left turned off would be under \$10 dollars per day. With the owner's permission, this capacitor bank was then turned off. Since that time, which is almost 2 years now, the metal spinning equipment has never crashed again due to this utility capacitor grid switching phenomena.
